# FOUNDATION SUPPORTWORKS™

POWERBRACE™ SYSTEM

**Foundation Supportworks™ stabilizes cracked & bowed basement walls with our proven, engineered PowerBrace™ system.**

## **POWER** FOUNDATION WALL REINFORCEMENT **BRACE™**

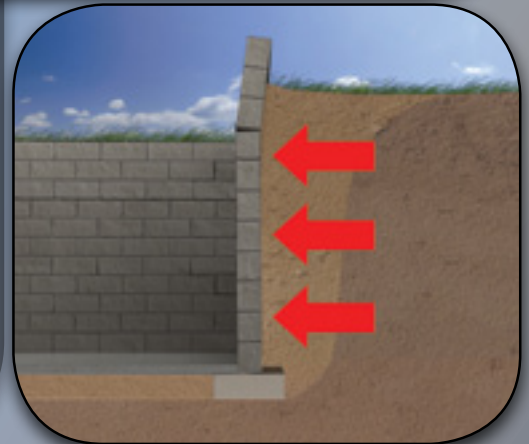
▶ While there are a number of potential causes of cracked and bowing foundation walls, the most common reason is pressure from the soil near the outside of the wall. When clay soils get wet, they expand and put pressure on the wall. When the force exceeds the strength of the wall, the wall cracks or breaks. This reduces the structural integrity of the wall, and when the wetting cycle is repeated, this causes further weakening and inward movement.

Other factors include heavy rains [causing hydrostatic pressure] and other structures [ie driveways, porches] putting pressure on the wall, large tree root systems, expansion due to frost, and poor grading.

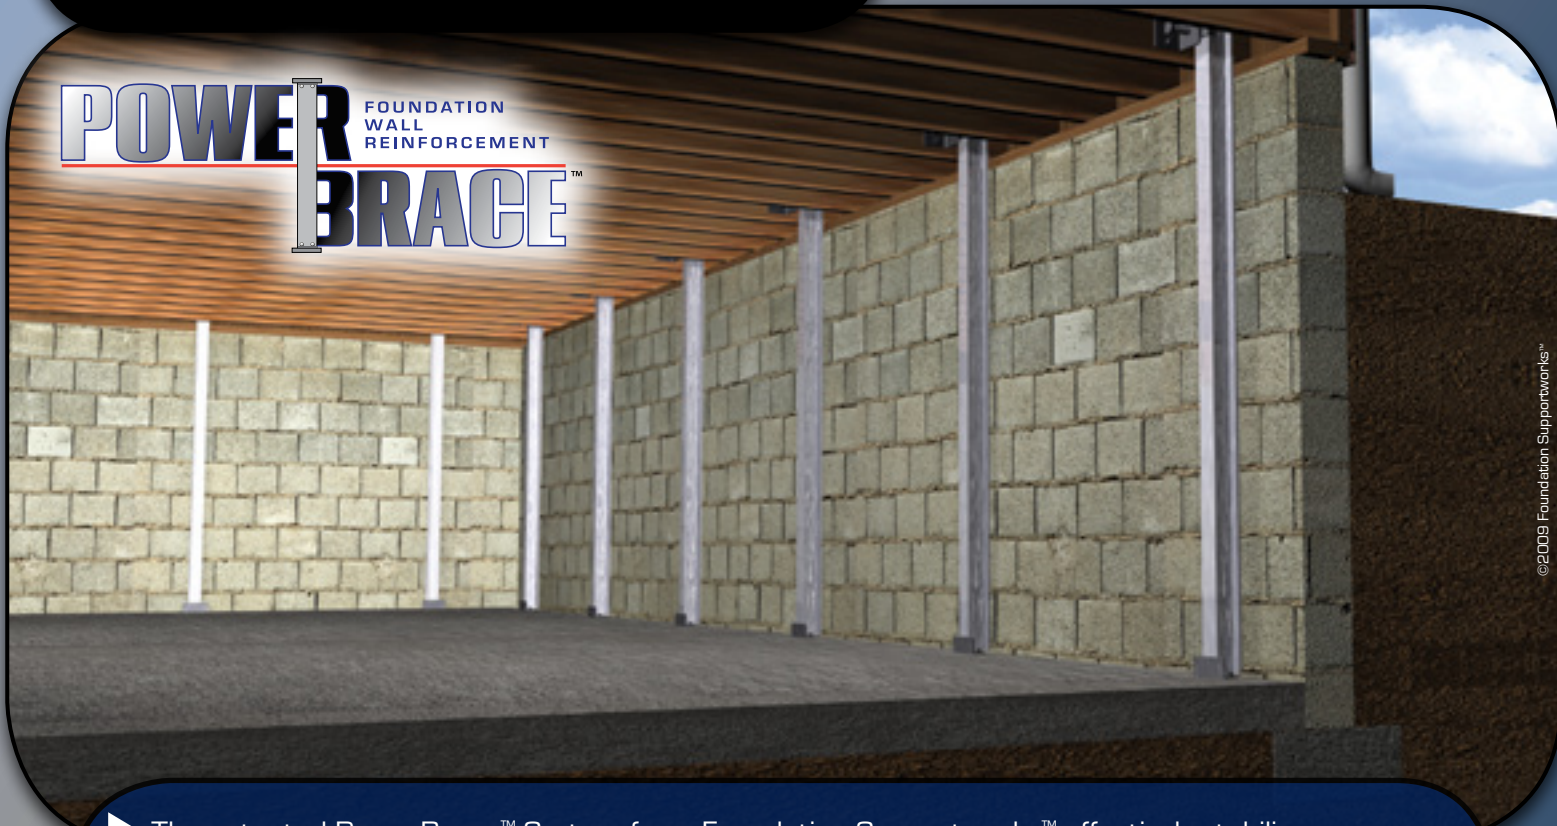
- ▶ The patented PowerBrace™ System from Foundation Supportworks™ effectively stabilizes your basement walls, in turn protecting your largest investment – your home. Heavy-duty, zinc-plated steel beams are custom-fit to your basement wall height. The beam is then secured tight against your basement wall with heavy-duty steel brackets that are anchored to your basement floor and floor joists. The steel beams will stabilize the wall in its current position, without any further adjustment. A unique, patented approach to the PowerBrace™ design is the ability to continue to tighten the system during the dry season for possible wall improvement.

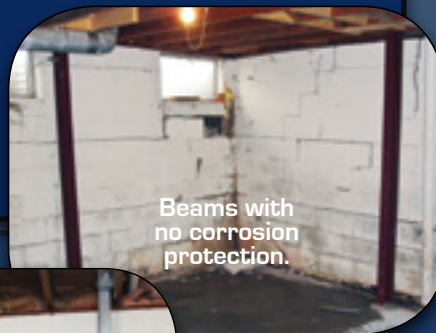
Beams with no corrosion protection.

To protect the system from corrosion, all components of the Foundation Supportworks PowerBrace™ System are zinc-plated in accordance with the American Society for Testing and Materials (ASTM) B633 standards for zinc coatings on steel. Most steel beam systems offered by contractors are installed using black, uncoated steel or painted steel. Unprotected steel offers very little resistance to corrosion, resulting in a rusted and unsightly system in your basement living space as well as potential health concerns.

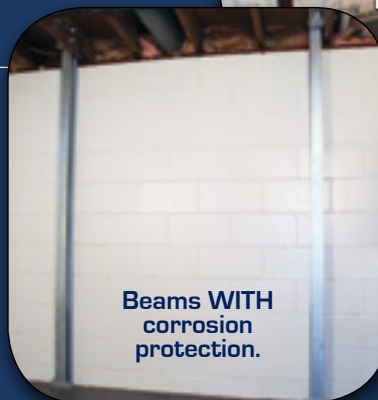
Beams WITH corrosion protection.

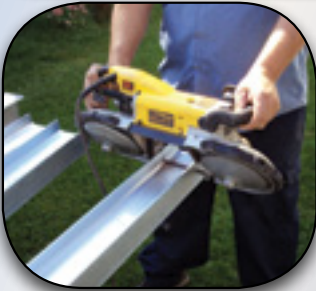
### STEP 1

Basement wall height is measured, and the PowerBrace™ steel beam is cut to the appropriate height.

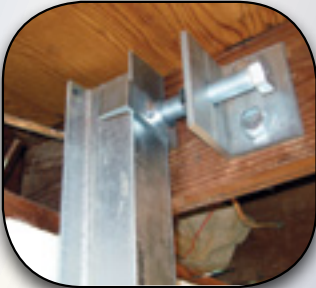
### STEP 2

The top of the steel beam is fastened and secured to the floor joists.

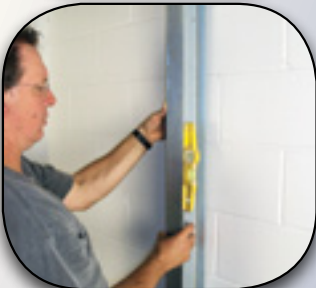
### STEP 3

The PowerBrace™ beam is plumbed.

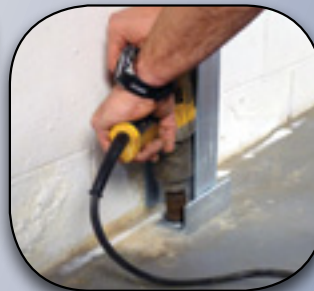
### STEP 4

The bottom of the steel beam is anchored to the concrete floor.

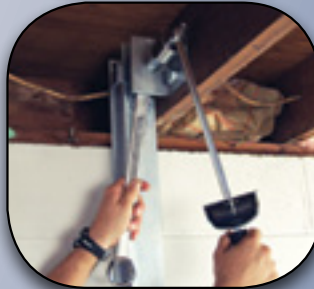
### STEP 5

The PowerBrace™ System can be tightened at intervals for possible wall improvement.

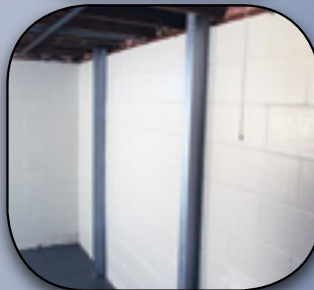
### STEP 6

Additional PowerBraces™ are installed using the same procedure.
